# **Impact of NiB Coating on the Efficiency, Scuffing, and Wear of Gear Contacts**

**by Ahmet Kahraman**

**ARL-CR-713**

**GearLab – Gear and Power Transmission Research Laboratory  
The Department of Mechanical and Aerospace Engineering  
The Ohio State University  
201 West 19th Ave.  
Columbus, OH 43210**

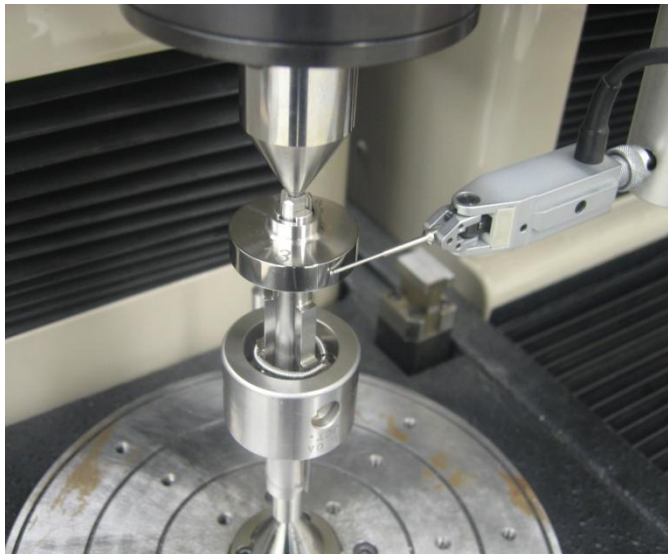
Figure 13. A disk (a) and roller specimen (b) being measured on the gear CMM.

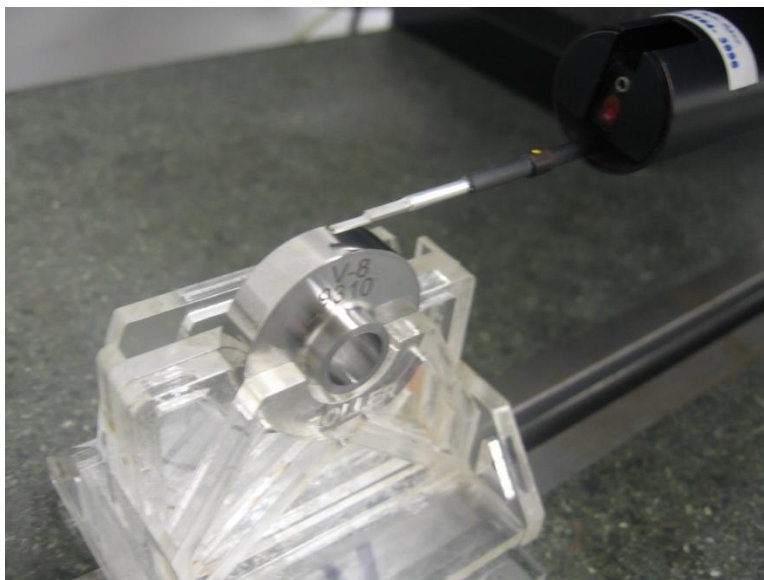
Figure 14. A disk (a) and roller specimen (b) being measured on the surface roughness profiler.

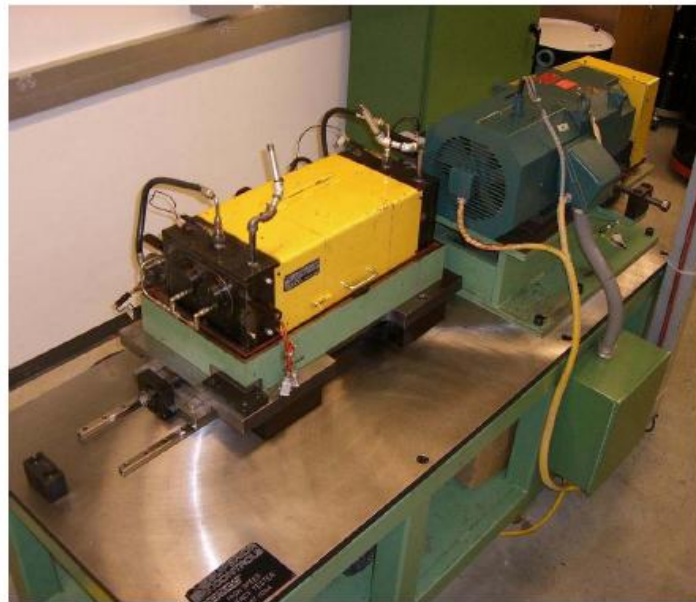
Figure 33. Gear efficiency test machine used in this study (7).

The gear efficiency test machine shown in figure 33 was used in this study. This setup was used in earlier spur (4–6, 13, 33) and helical (7) gear efficiency studies. Only the essential details of the test setup will be provided here, as complete details of the test machine and related instrumentation can be found in those earlier studies.

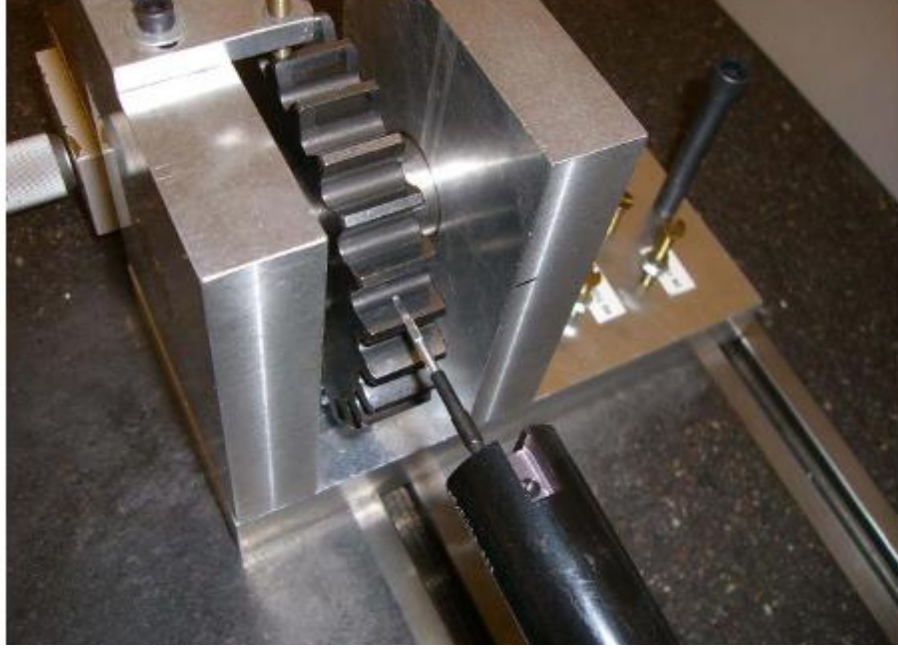
Figure 38. Measurement of a test gear on a surface roughness profiler (6).
